BURTON DUENKE NO. 3 LAKE DAM

CAMDEN COUNTY, MISSOURI

MISSOURI INVENTORY NO. 31609

PHASE I INSPECTION REPORT
NATIONAL DAM SAFETY PROGRAM

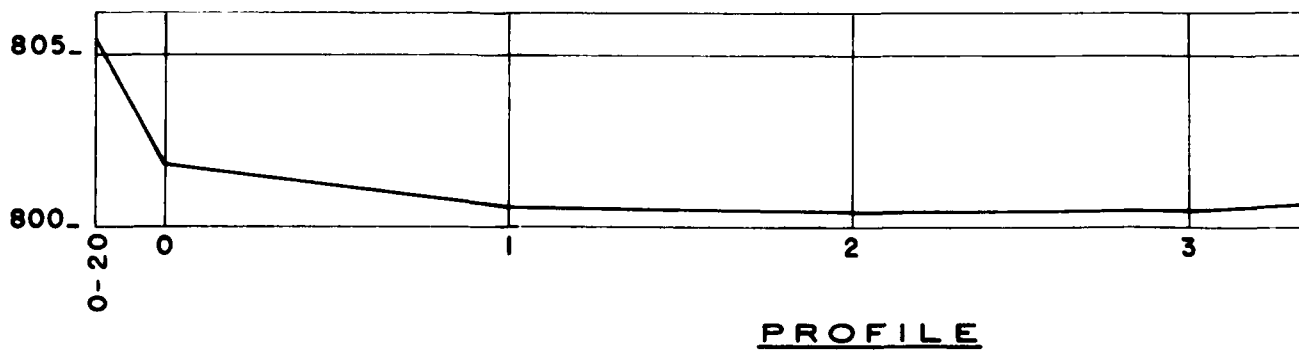
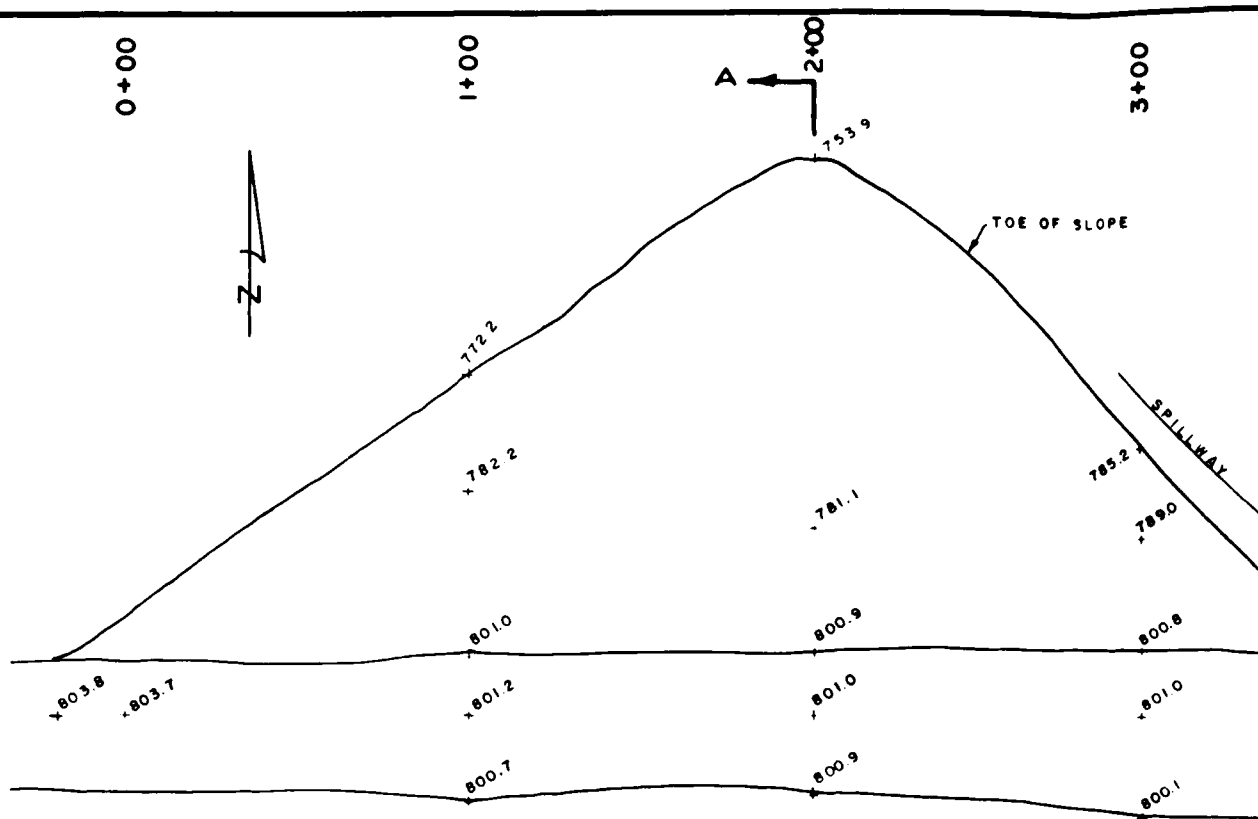
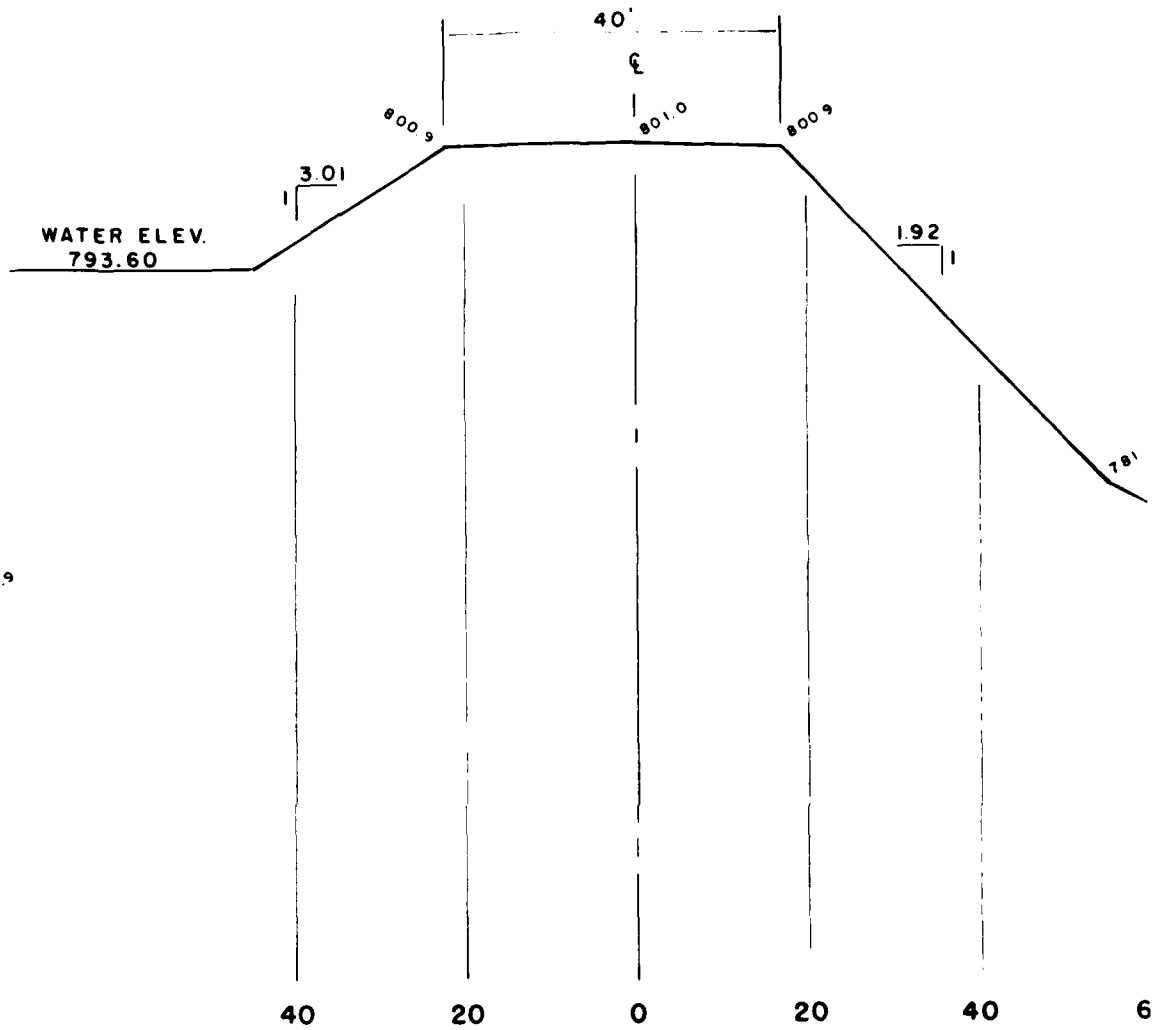
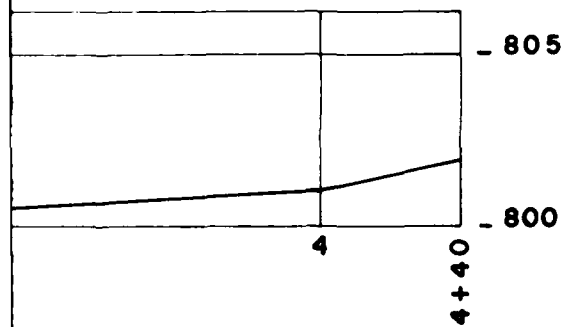
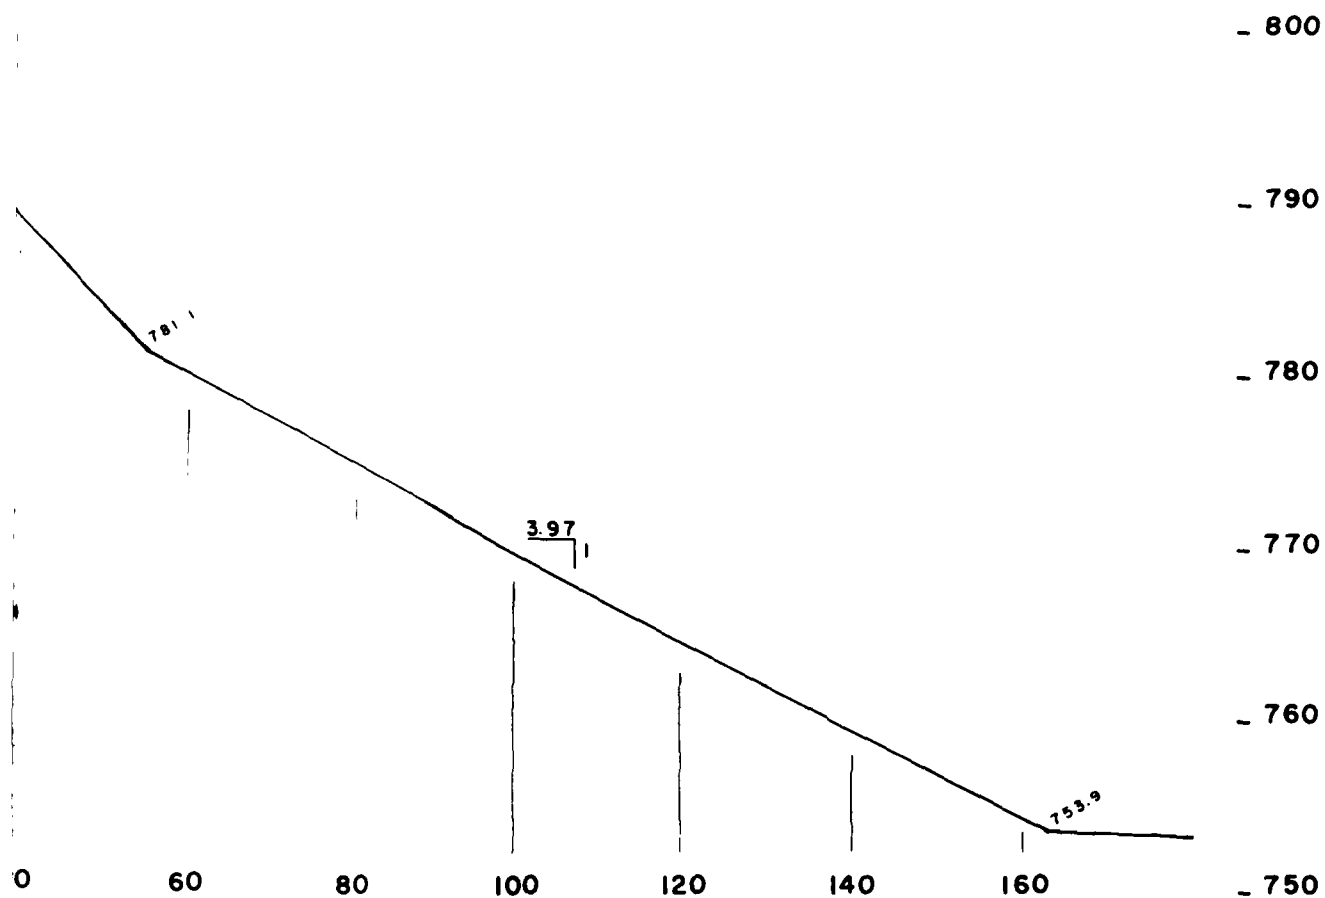
SHEET 3 APPENDIX A

Sheet 3 of Appendix A shows a plan profile and typical section of the embankments.
